Appendix K—Streambank Stability

STREAMBANK STABILITY CLASSIFICATION KEY

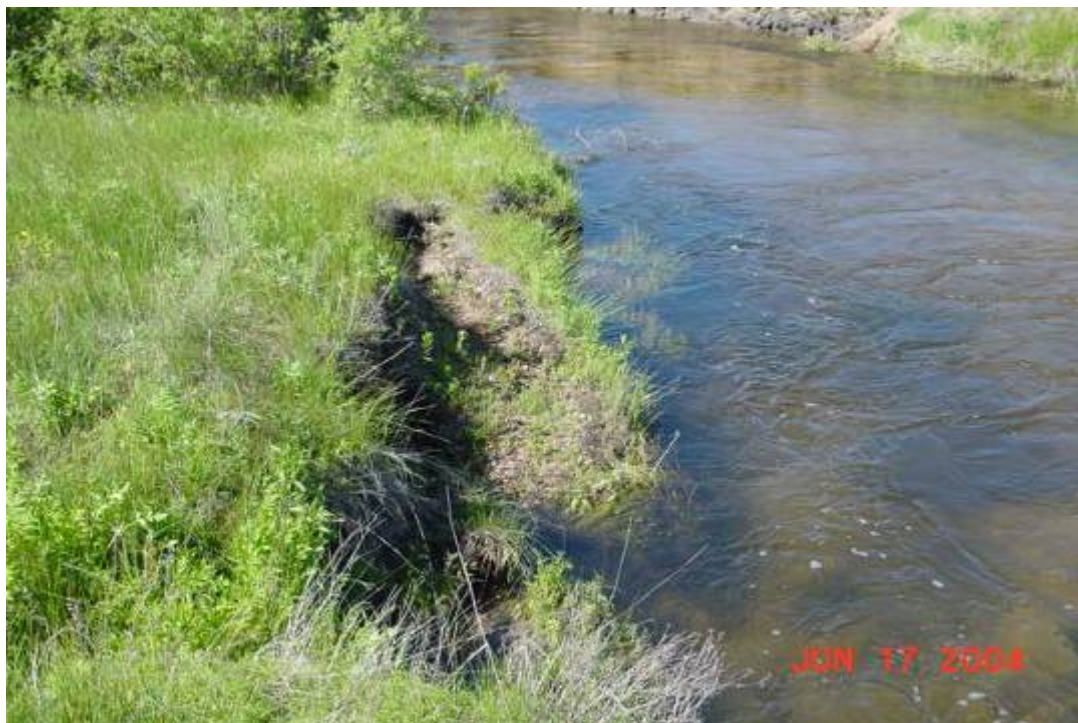
Figure 4—the photo above shows a fracture and a large slump that is still attached to the streambank. Vegetation cover is at least 50 percent canopy cover and is classified as covered/unstable (CU). (see Illustration 4)

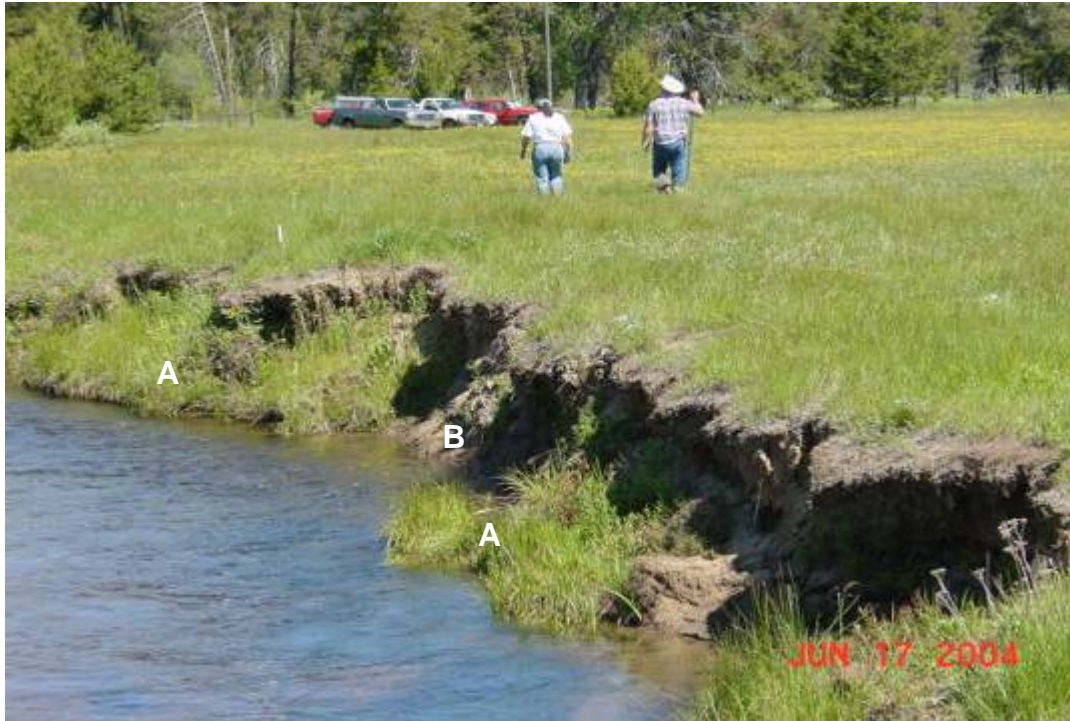
Figure 5—the stream in this photo is flowing at the scour line. Slumps “A” are still attached the bank above the scour line and would be classified as covered/unstable (CU) (See Illustration 4). “B” has no vegetation along the streambank and is uncovered/unstable (UU) (See Illustration 4).

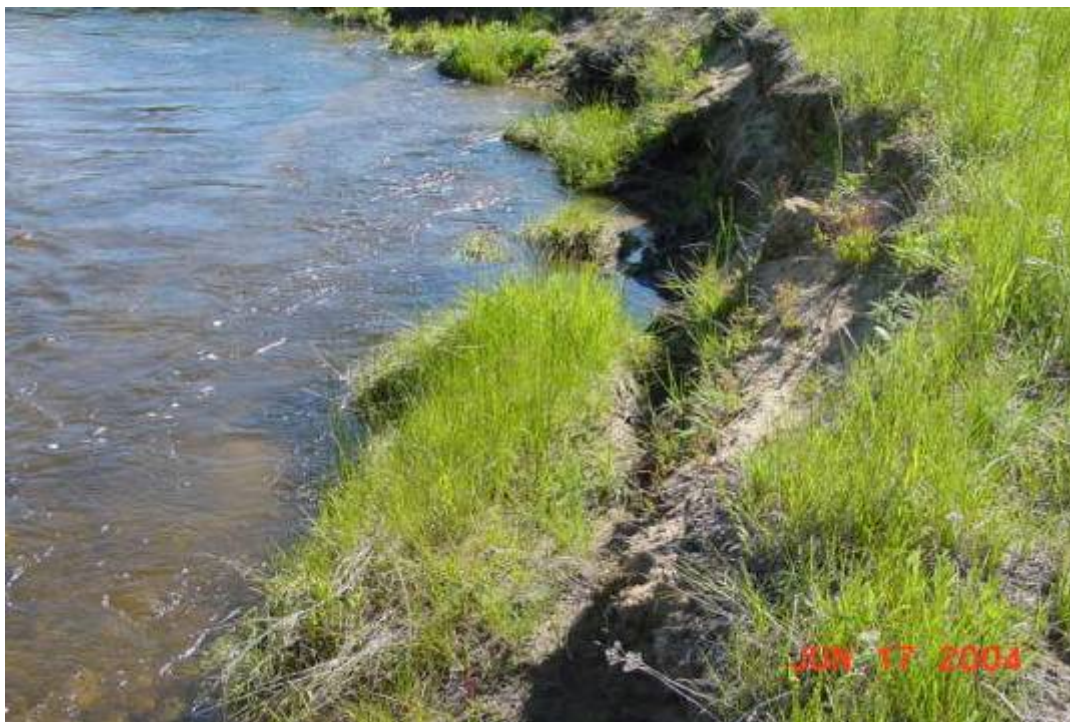
Figure 6—the slump bank is still attached to the bank above the scour line and is covered/unstable (CU) (see Illustration 4)

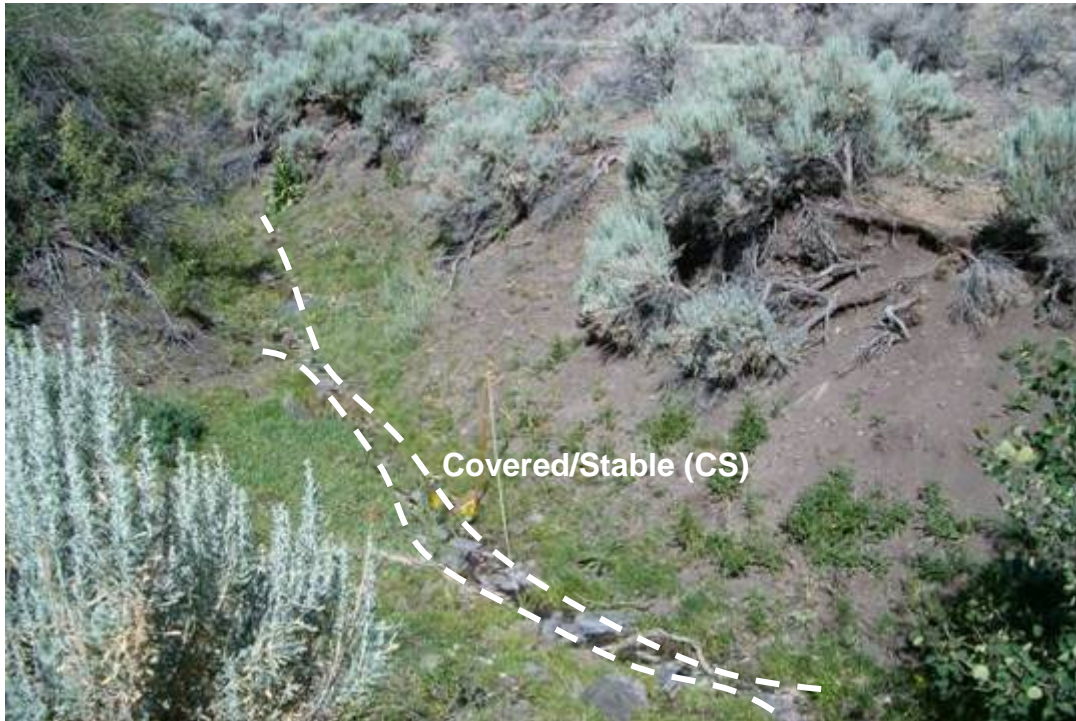
Figure 9—the scour line and greenline are at approximately the same location. The streambank has at least 50 percent vegetation cover and is not eroding. Thus is classified as covered/stable (CS). Photo- PIBO, U.S. Forest Service.

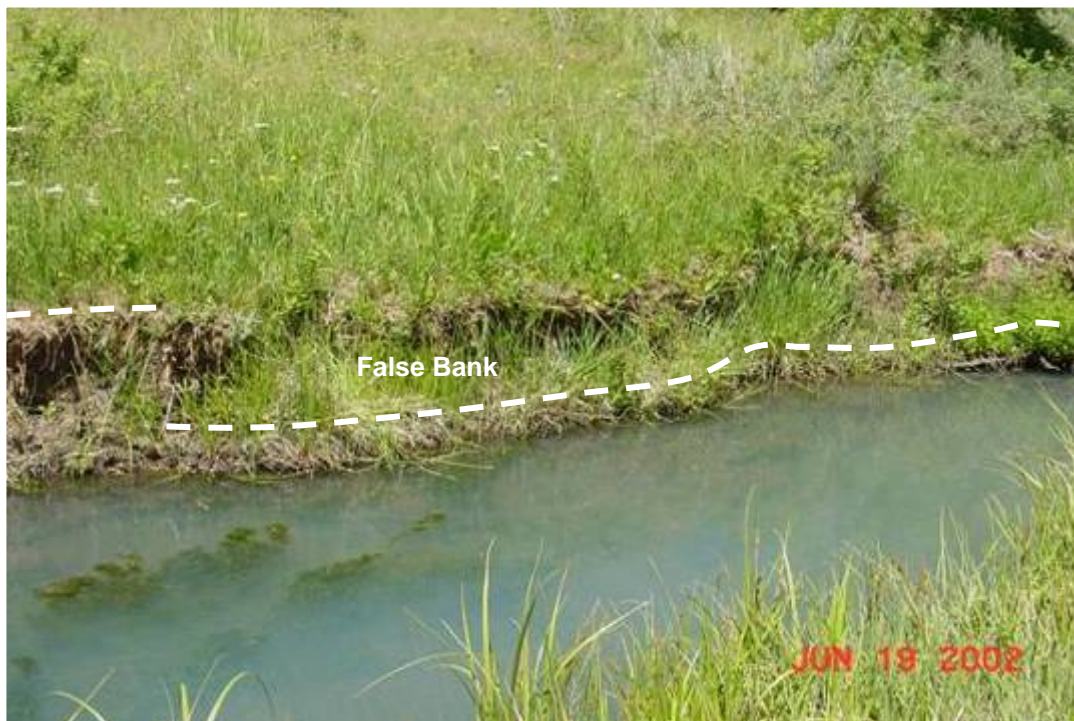
Figure 10—false banks are slump features that is reattached and with deep-rooted vegetative cover and is stable.

False Bank: Stream banks have slumped in the past but have been stabilized by relatively shallow-rooted vegetation. These banks are usually lower than the terrace. False banks vegetated with deep-rooted riparian vegetation may be considered stable and should be counted separately and added to the stable category.
